# Remediation of the Ruddiman Creek Main Branch and Pond Muskegon County, Michigan

## Great Lakes Legacy Act Program

March 2011

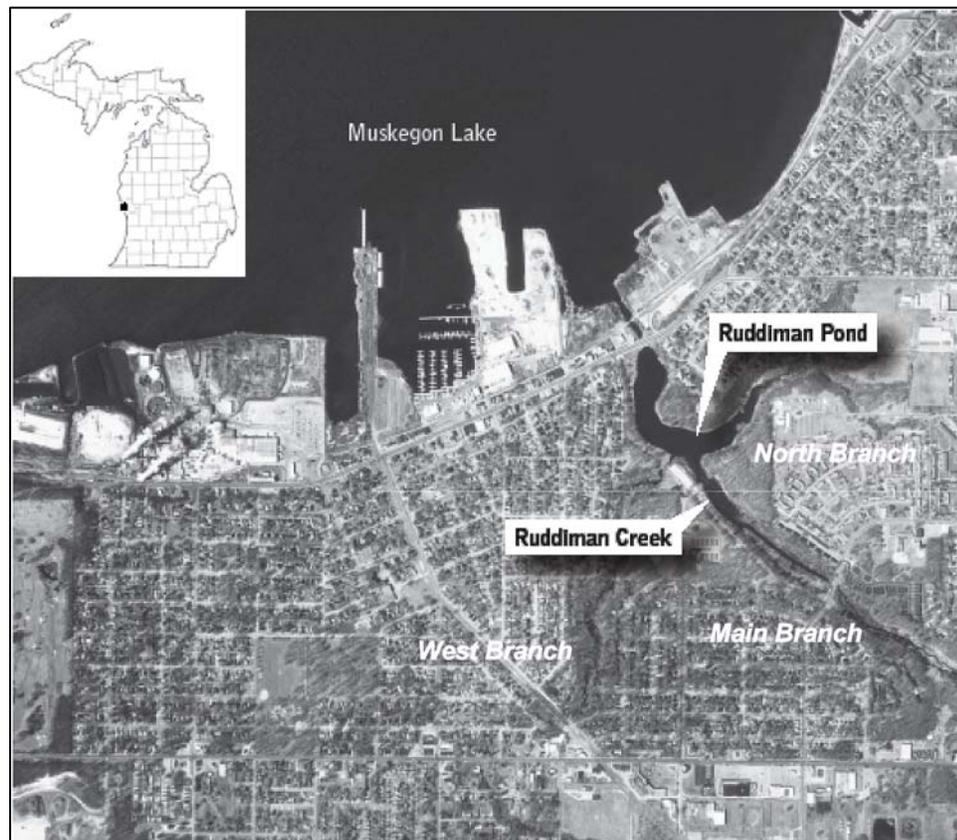
**Figure 1-1 Ruddiman Creek and Pond**

The Main Branch begins at a 100-inch storm sewer outfall located east of Barclay Road and flows through residential and wetland areas and discharges into the southeastern portion of Ruddiman Pond. The Main Branch varies in width from 10 to 60 feet, and typically has low-flow water depths ranging between 1 and 7 feet. The mean flow rate for the creek is 3.1 cubic feet per second. The width, depth, and flow increase during heavy rain and spring thaw.

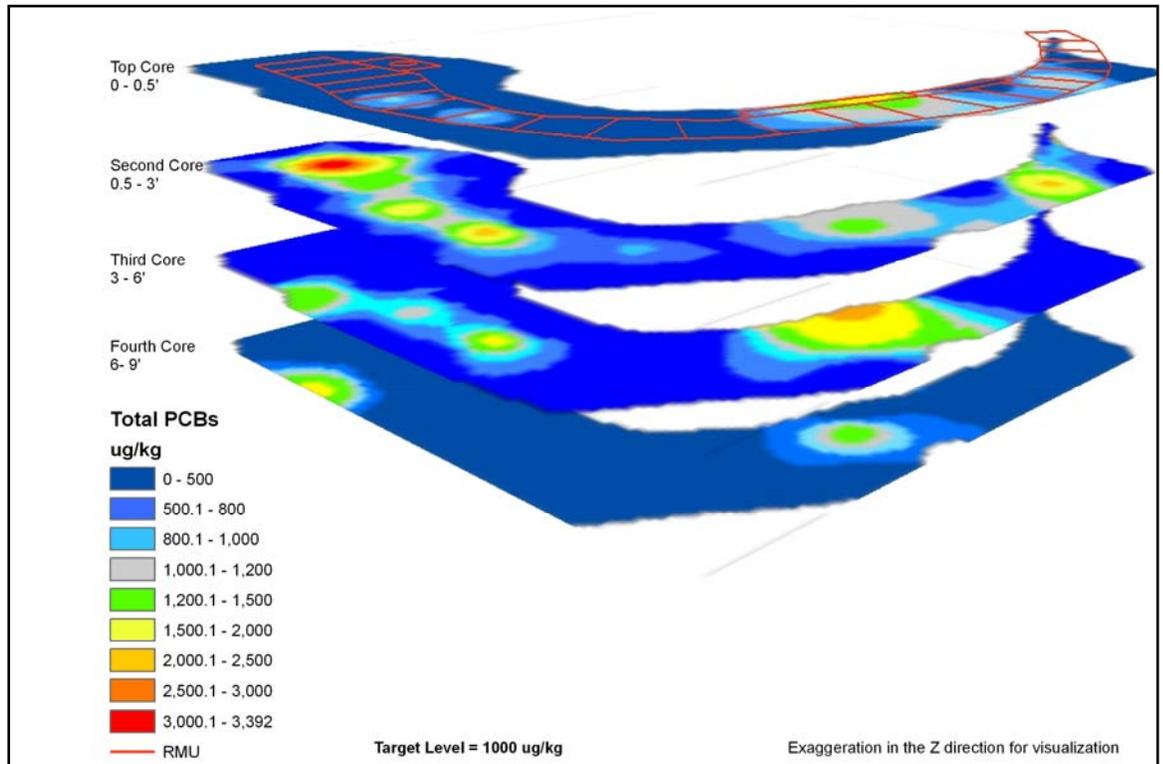
**Figure 1-3 Pre-remediation sediment total PCB concentrations at depth**

Contamination of the sediments was observed from 0 to 9 feet below the surface of the sediment. Figure 1-3 illustrates the relationship between total PCB concentration and depth below the surface. The results are presented in µg/kg, the units used by the laboratory that analyzed the samples (decimal points in the figure legend simply indicate that the listed ranges do not overlap).

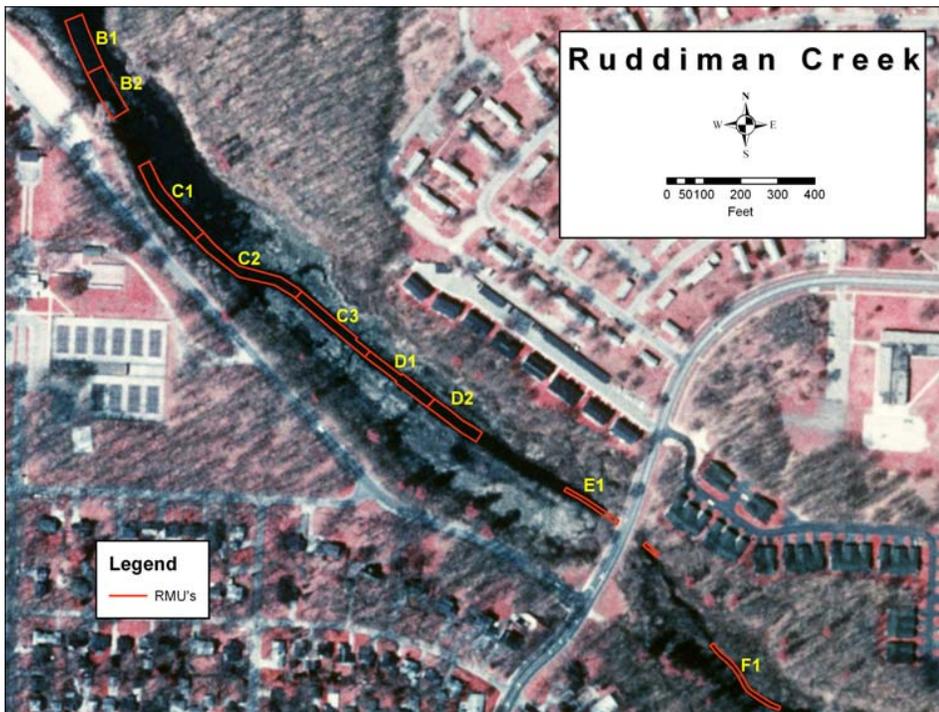
Figure 2-1 Ruddiman Creek Main Branch RMUs B, C, D, E, and F (upstream)

remediation area are depicted in Figures 2-1 and 2-2. The RMUs associated with the Ruddiman Pond remediation area are depicted in Figure 2-3.

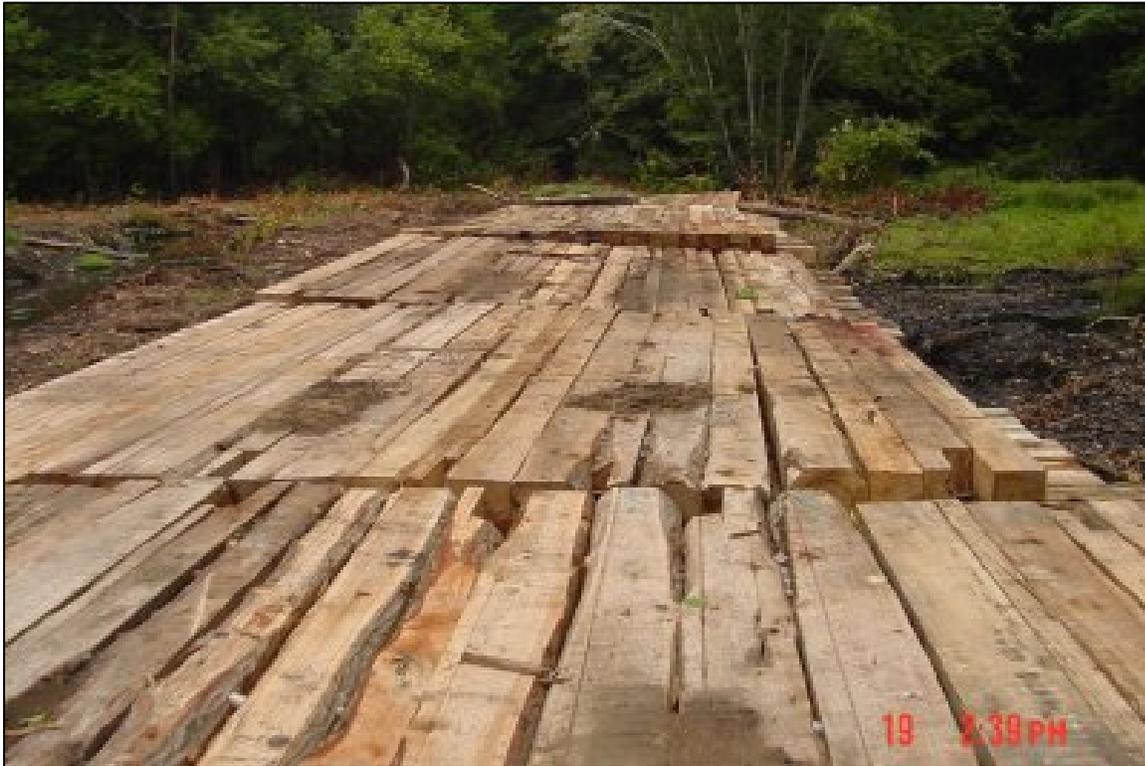
A combination of sand/geosynthetic/gravel roads and HDPE interlocking road mats were used to construct the roadways to reach Ruddiman Creek Main Branch Areas E, D, C, and B.

**Figure 2-4** Timber swamp mat access road to Ruddiman Creek Main Branch remediation area

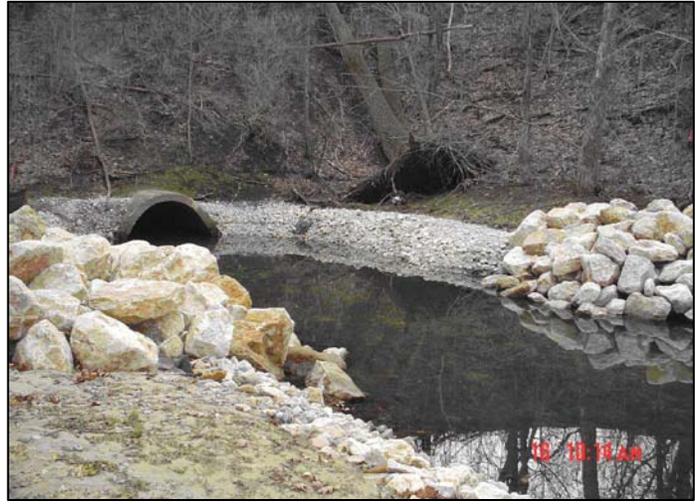
**Figure 2-5 Headwater dissipation structure**

was built west of the 100-inch outfall, illustrated in Figure 2-5, to preclude suspended sediments that may have eroded or been scoured by storm water surges at the outfall from settling in any of the work areas downstream.

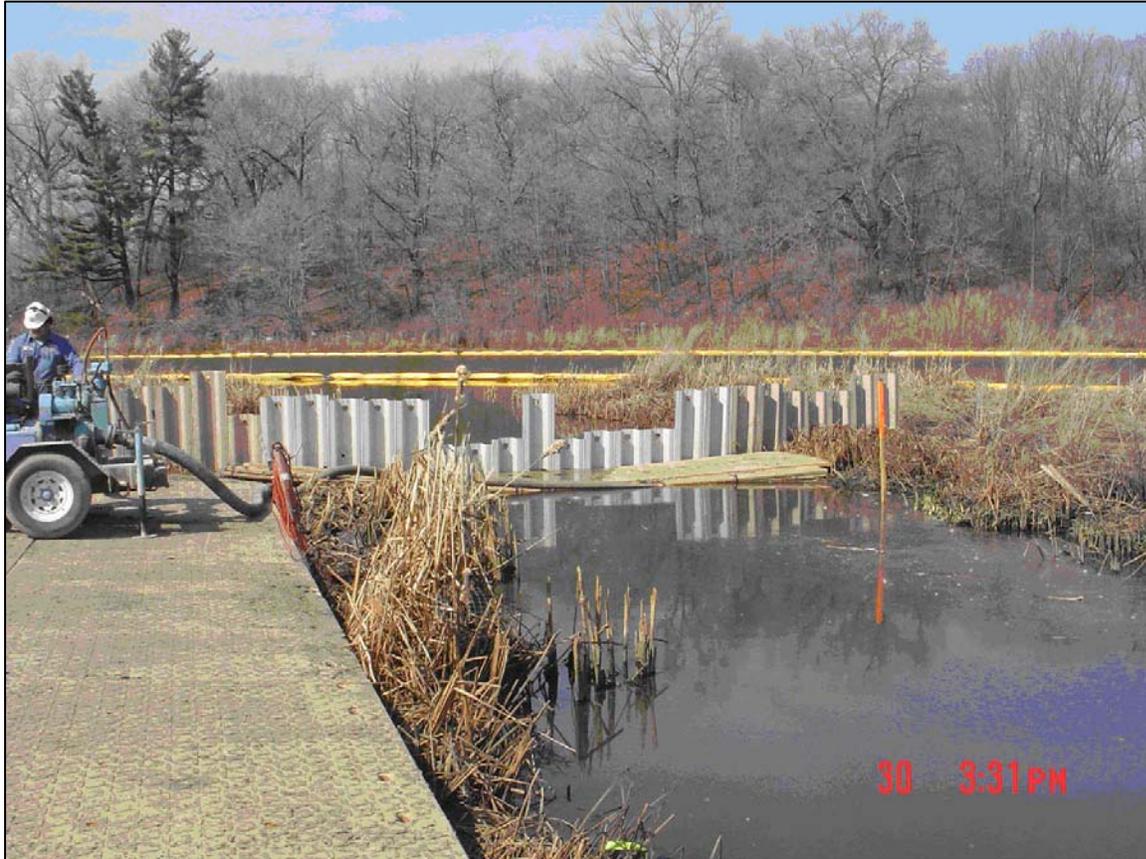
The excavation areas in the Ruddiman Creek Main Branch were isolated with sheet piling to block or dam the natural water flow, as illustrated in Figure 2-6. Sheet pile dams were installed upstream and downstream from each excavation area, with the exception of Areas H and I, where an earthen dam was constructed using sand, stone, and polyvinyl chloride (PVC) liner material.

**Figure 2-6 Sheet piling isolating a portion of a creek channel**

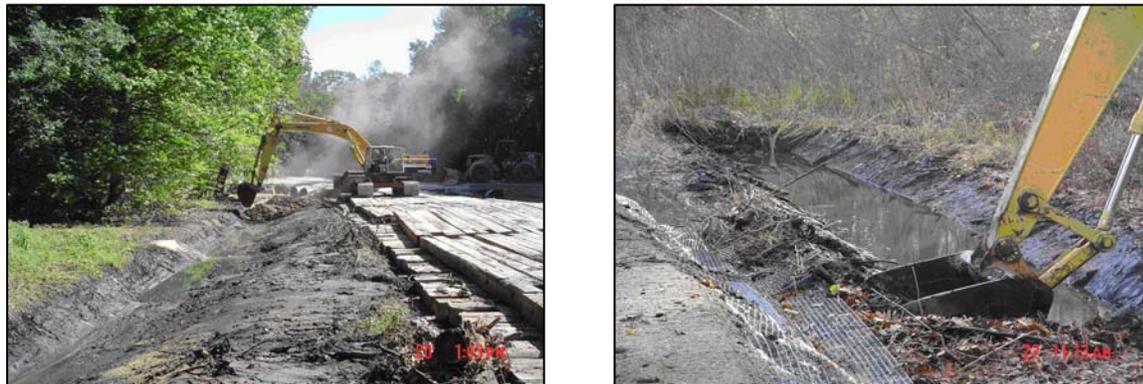
Diversion channels were created around Areas G and F to allow the creek to flow around the excavation areas and to minimize infiltration of water into the excavation areas (Figure 2-7).

**Figure 2-7 Creating a diversion channel around Area G using a tracked excavator (left). Construction of diversion channel around Area F (right).**

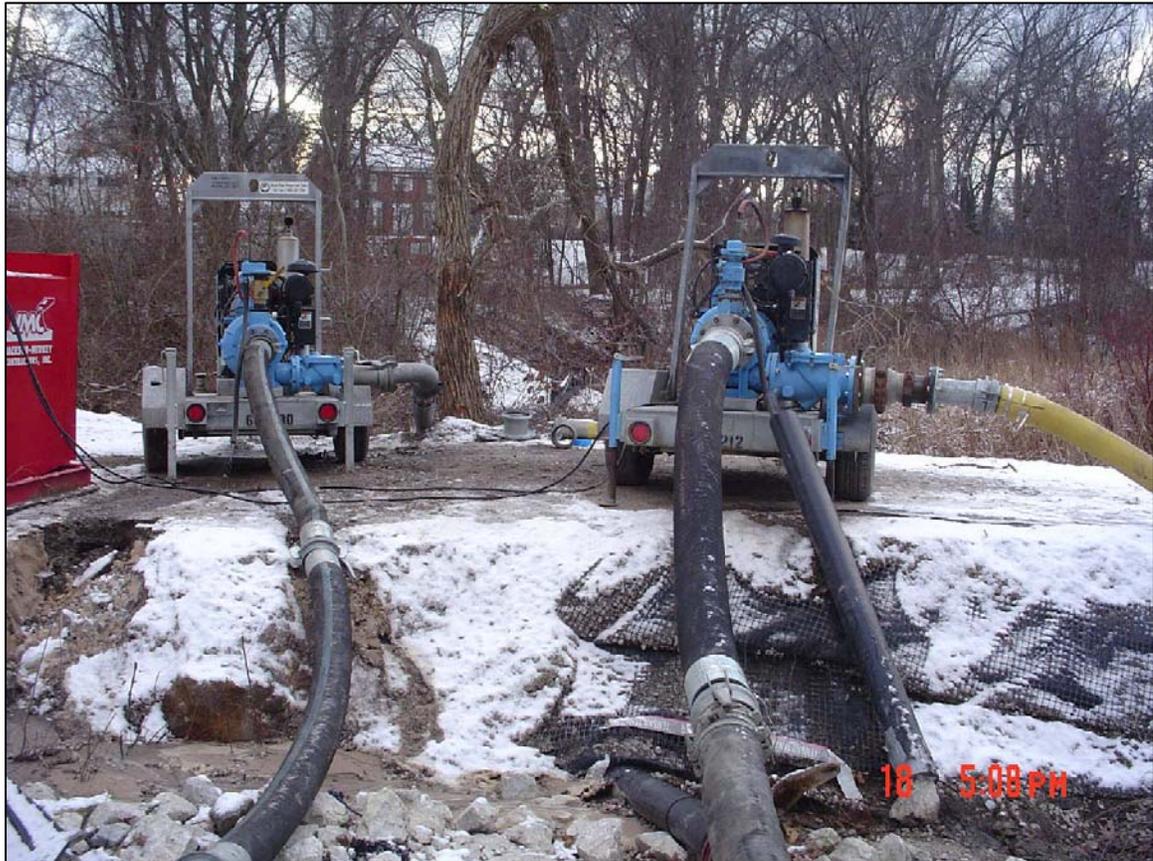
Groundwater and surface water runoff from storm events that accumulated in the excavation areas was pumped to the on-site water treatment system (Section 4.2.2). In addition, by-pass pumping occurred around Areas B, C, D, H, and I (Figure 2-8).

**Figure 2-8** By-pass pumping around Areas D and C

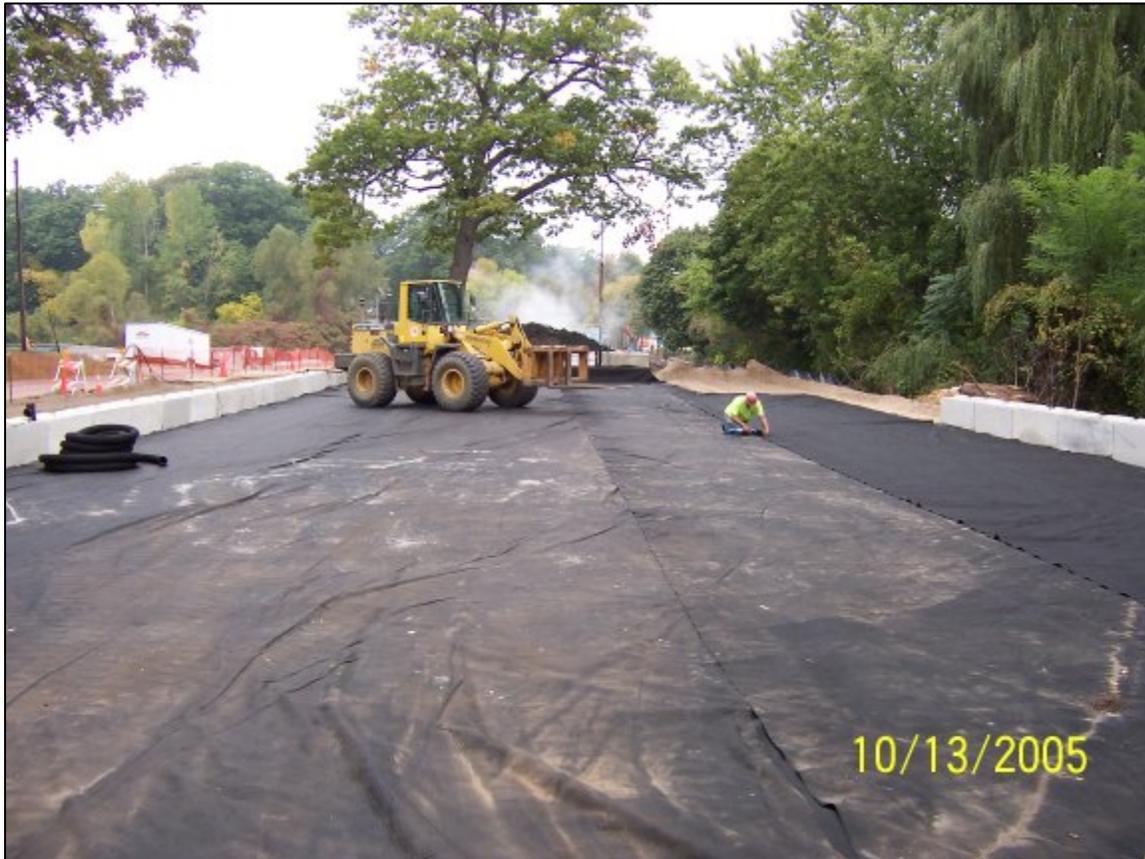
dewatering area at the pond to sit and allow free water to decant, as illustrated in Figure 2-9. The dewatered material was transported to an off-site landfill (see Section 3.3).

**Figure 2-9 Sediment dewatering pads**

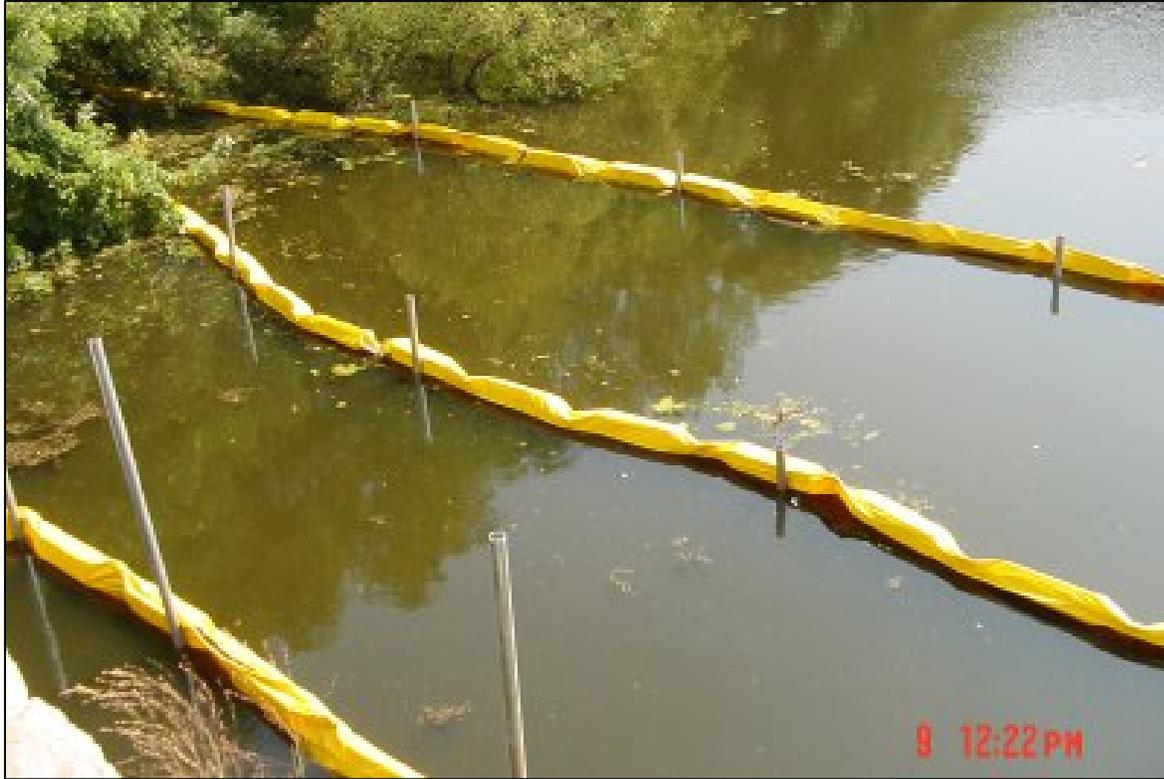
With the exception of Area A3 (Figure 2-3), the turbidity curtains were reconfigured to seal off each areas as dredging was completed. For example, upon completion of dredging in Area A5, the curtains were reconfigured to exclude that area and seal off the east end of Area A3 to allow for dredging in Areas A3 and A4. While those areas were being dredged, new curtains were deployed to seal off Areas A1 and A2. The curtains in Area A3 remained in place until all dredging operations were in place because Area A3 was used for access to all other areas of the pond. All of the curtains were inspected frequently, repaired as needed, and removed after completion of dredging operations.

**Figure 2-10 Isolation of Ruddiman Pond work areas using multiple silt curtains**

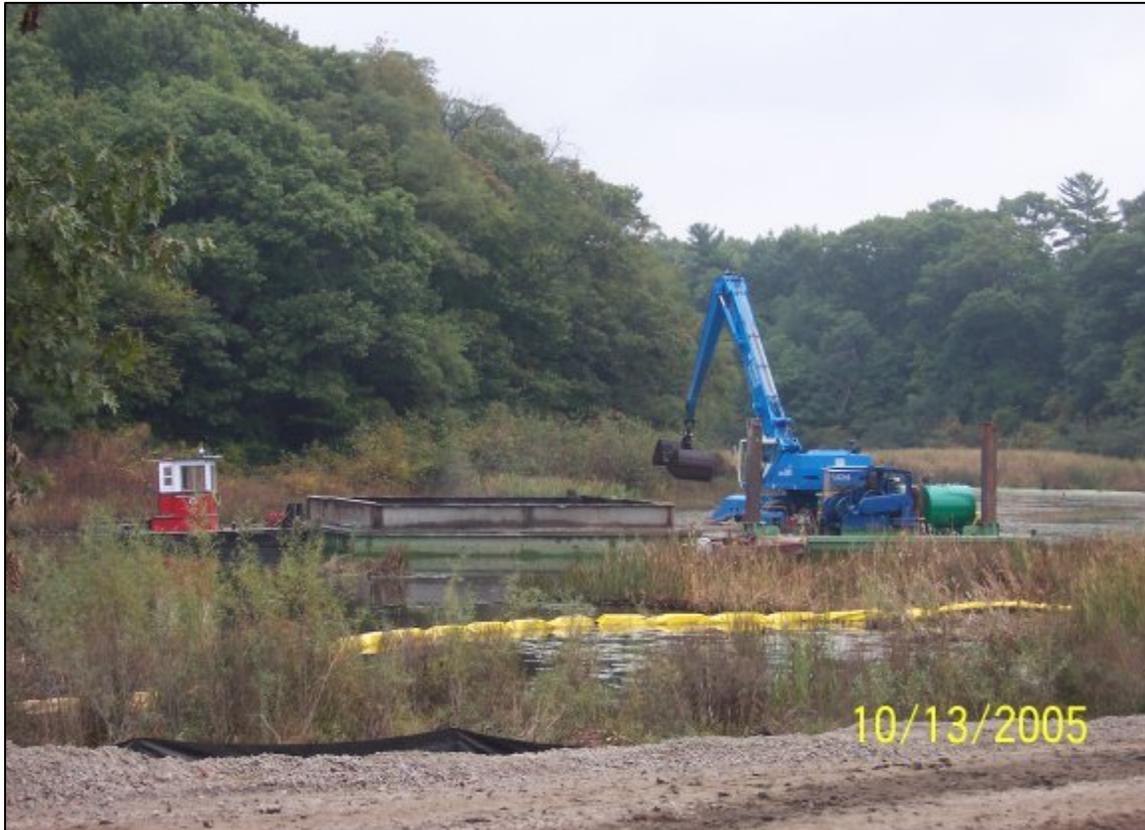
Each of the two material barges consisted of a 40 x 40-foot sectional barge with a 3-foot high steel wall welded in place two to four feet from the exterior perimeter. This created an area with a storage capacity of 70 to 90 cubic yards of material. The barge and dredging equipment were mobilized and launched from the offloading pier on September 1 and 2, 2005.

**Figure 3-1 Tug and barge dredging operations within the Ruddiman Pond remediation area**

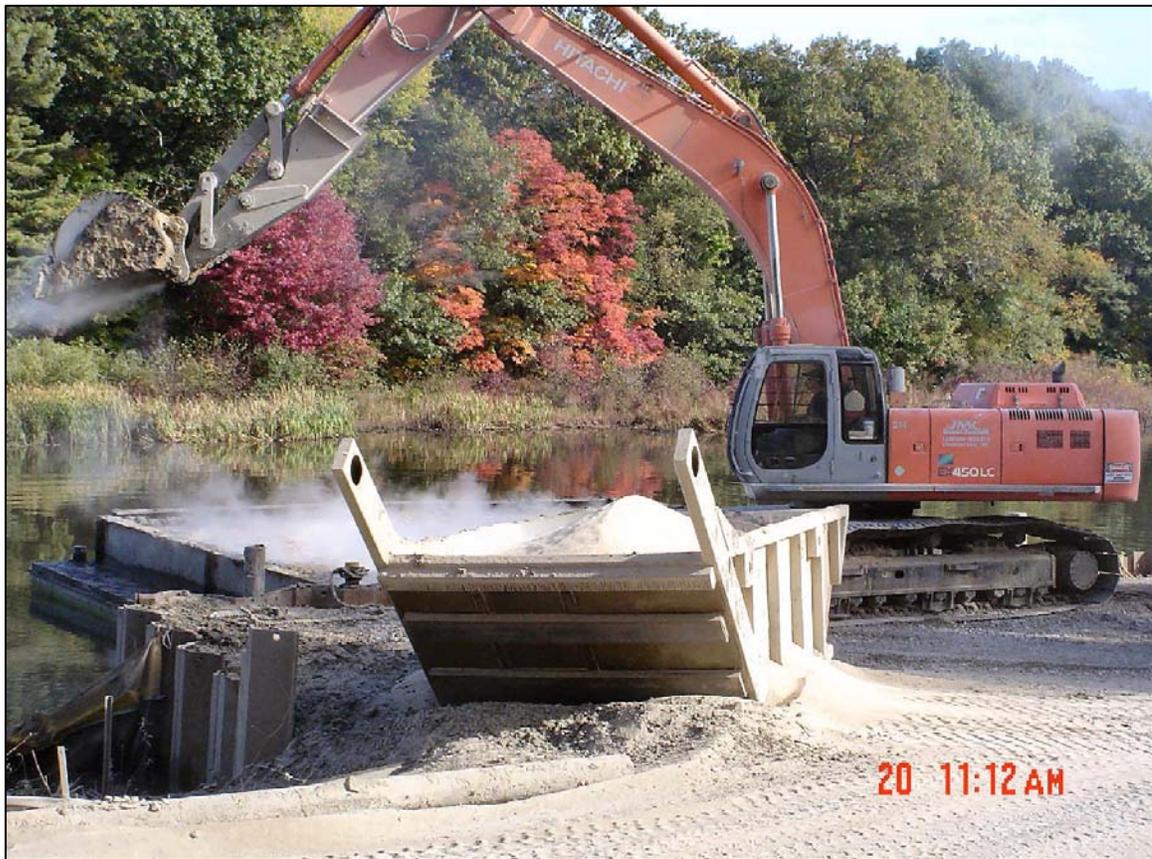
An excavator was used to mix Calciment<sup>®</sup> into the contaminated sediment, as shown in Figure 3-2. Some fugitive dust was generated from the Calciment<sup>®</sup> during mixing, as seen in Figure 3-2, and while efforts were made to minimize such dust, it could not be eliminated. The sediment was solidified before being loaded into dump trucks for hauling to the staging area. The solidification process released heat from the wet sediments, resulting in the steam seen rising from the mixture in Figures 3-3 to 3-5. The primary staging area used to dewater sediments removed from the pond and from Area B of the creek was located across from McGraft Park on the north side of McGraft Park Road. Three additional, temporary staging areas were used to load and transport solidified sediments from all other areas within the creek.

**Figure 3-2 Solidification of Ruddiman Pond sediment**

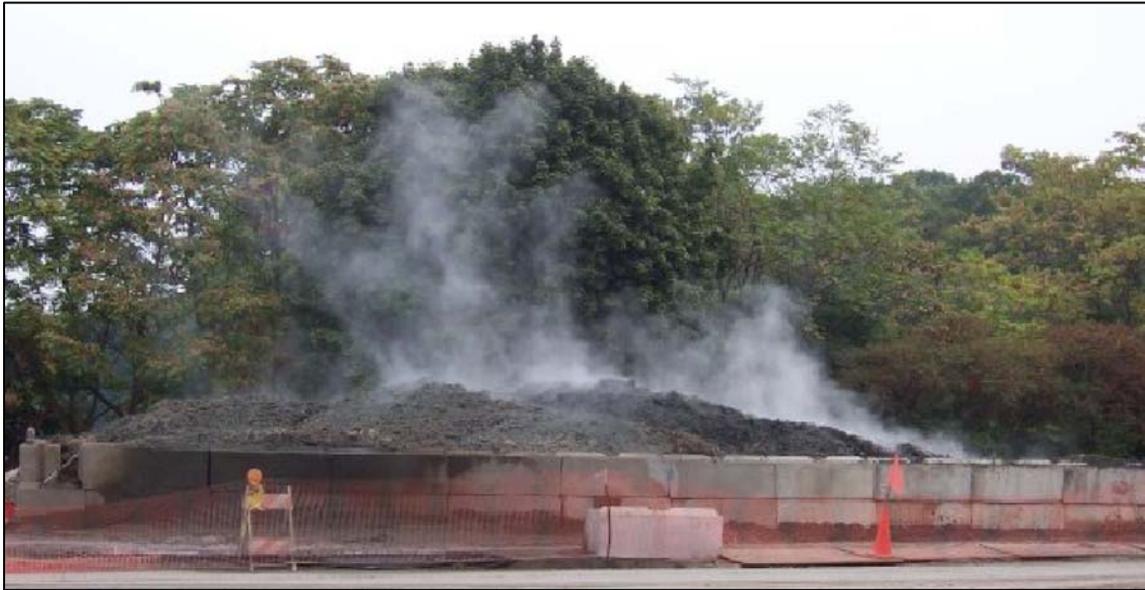
Excavated sediment that had been mixed with Calciment<sup>®</sup> was hauled to a drying bed for dewatering and solidification. The perimeter of the specially constructed drying bed was made of interlocking concrete blocks forming a rectangle (Figure 3-3). The foundation of the drying bed was made of sand, topped by a waterproof, heat-sealed, heavy plastic

membrane. All drainage from the sediment was collected in porous plastic pipe on top of the plastic liner and pumped to the treatment system (Section 4.2.2).

**Figure 3-3 Sediments mixed with Calciment<sup>®</sup> in the drying bed**

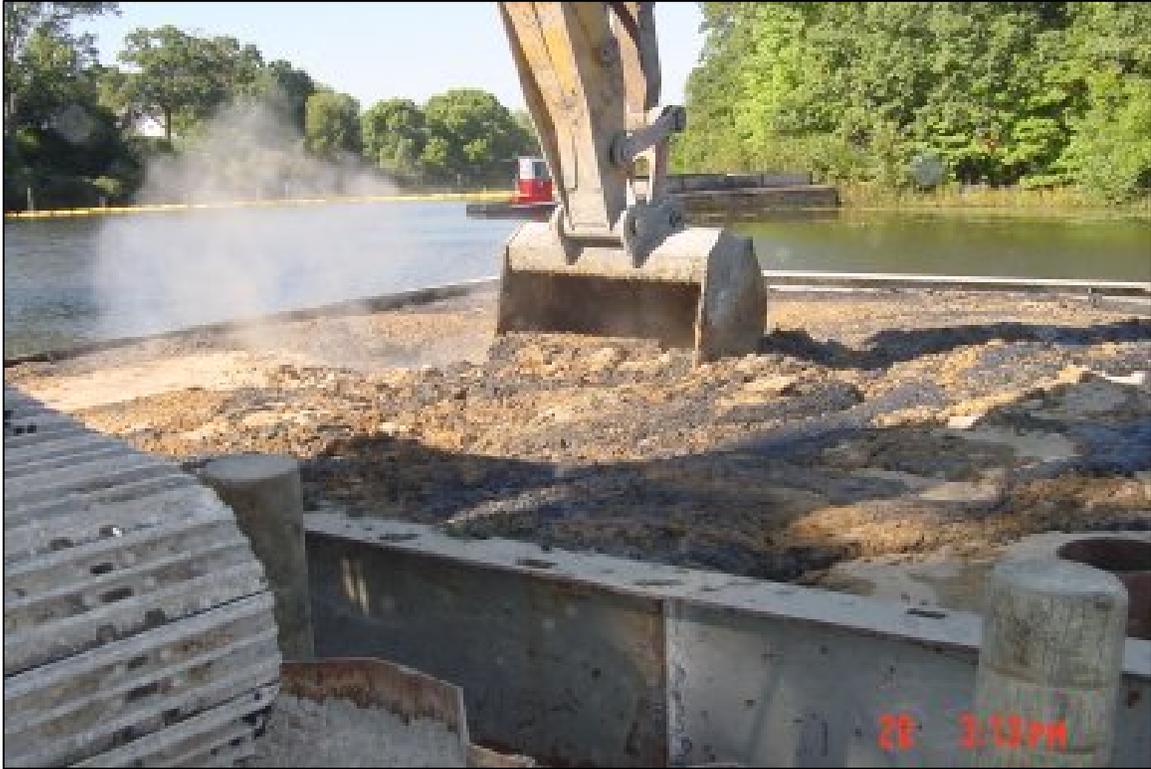
In Areas F, G, H, and I, Calciment<sup>®</sup> was added to the sediment in place. In other areas, Calciment<sup>®</sup> was added in a mix pit intermediate to the final staging area as the sediment was being removed or in the barge (Figure 3-4).

**Figure 3-4** Addition of Calciment<sup>®</sup> to sediments on the dredging barge

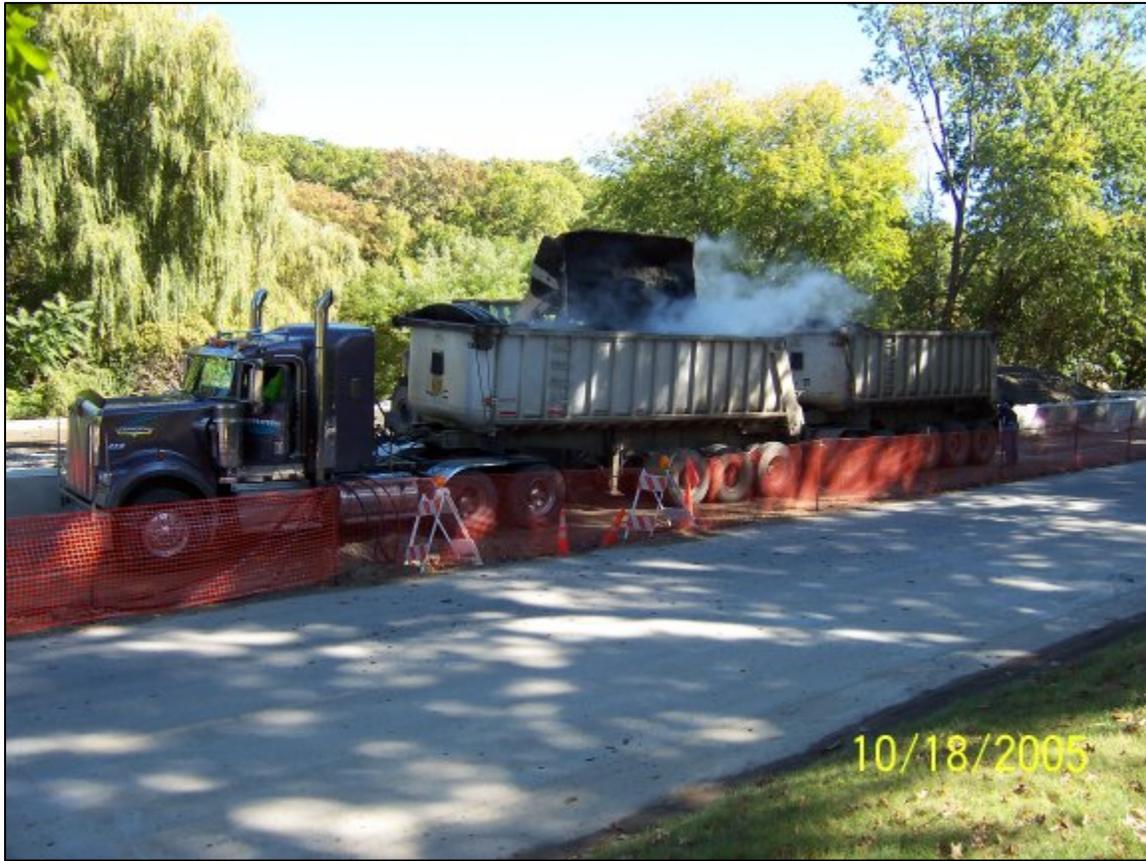
The contaminated water from the drying bed, along with other contaminated water from sediment removal operations, was treated to a level deemed acceptable by Muskegon County, and then pumped to a sewer manhole that drains to the Muskegon County Wastewater Facility for final processing. A total of 3,241 truckloads (157,645 tons) of creek and pond sediments, staging pad materials, and road material waste were transported approximately 22 miles to the Ottawa Farms landfill in Coopersville, Michigan, for disposal (Figure 3-5).

**Figure 3-5 Loading treated sediment for transportation to the Ottawa Farms landfill**

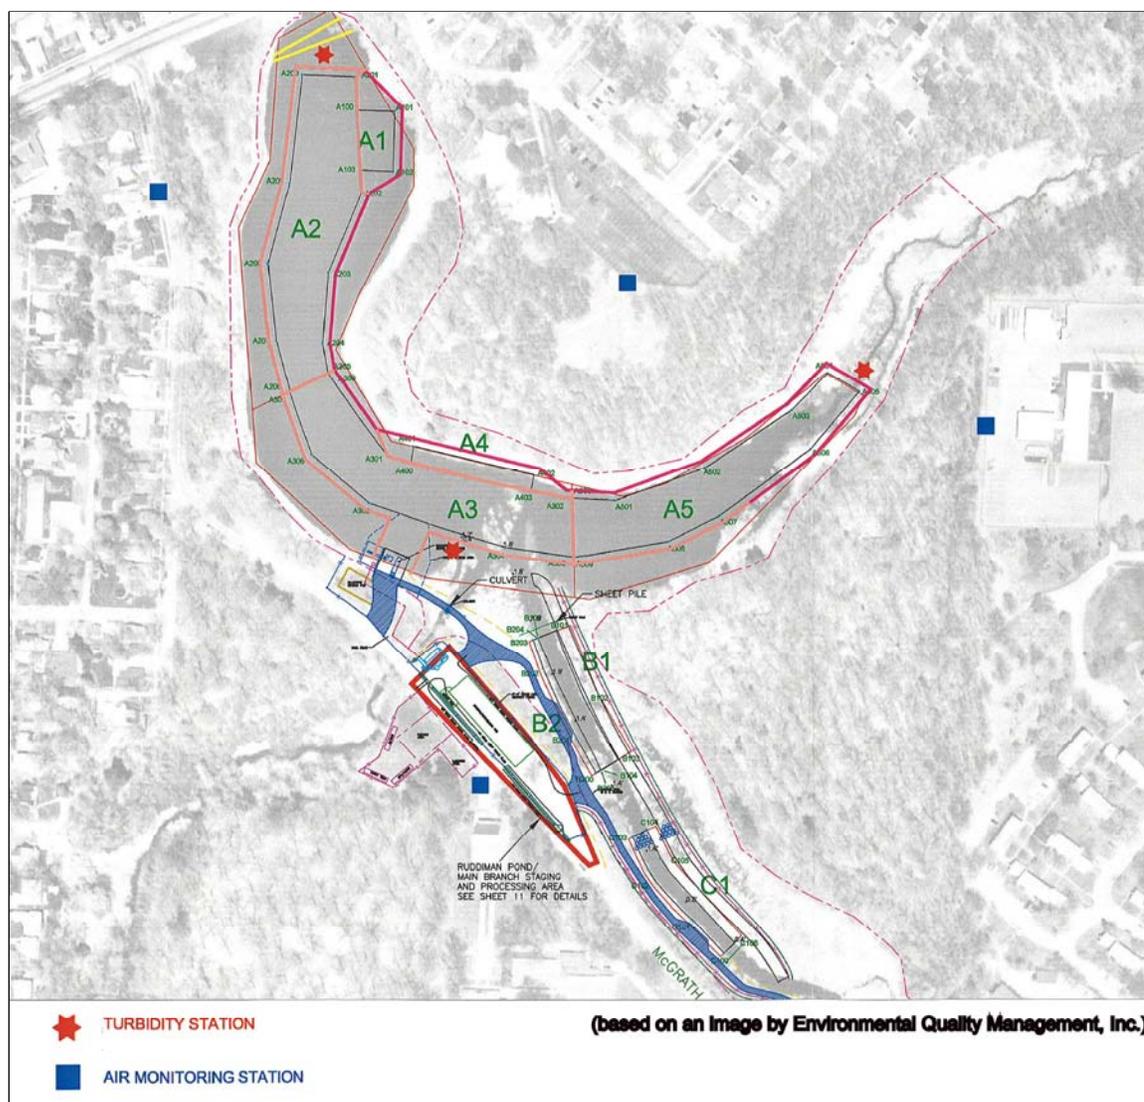
\* Three of the four pond sampling stations were located downwind (adjacent) to pond operations to reflect site conditions and one was located upwind of pond operations to reflect daily background levels. Two of the four creek sampling stations were located downwind and one was located upwind of creek operations.

**Figure 4-1 Location of monitoring stations at the Ruddiman Creek site**

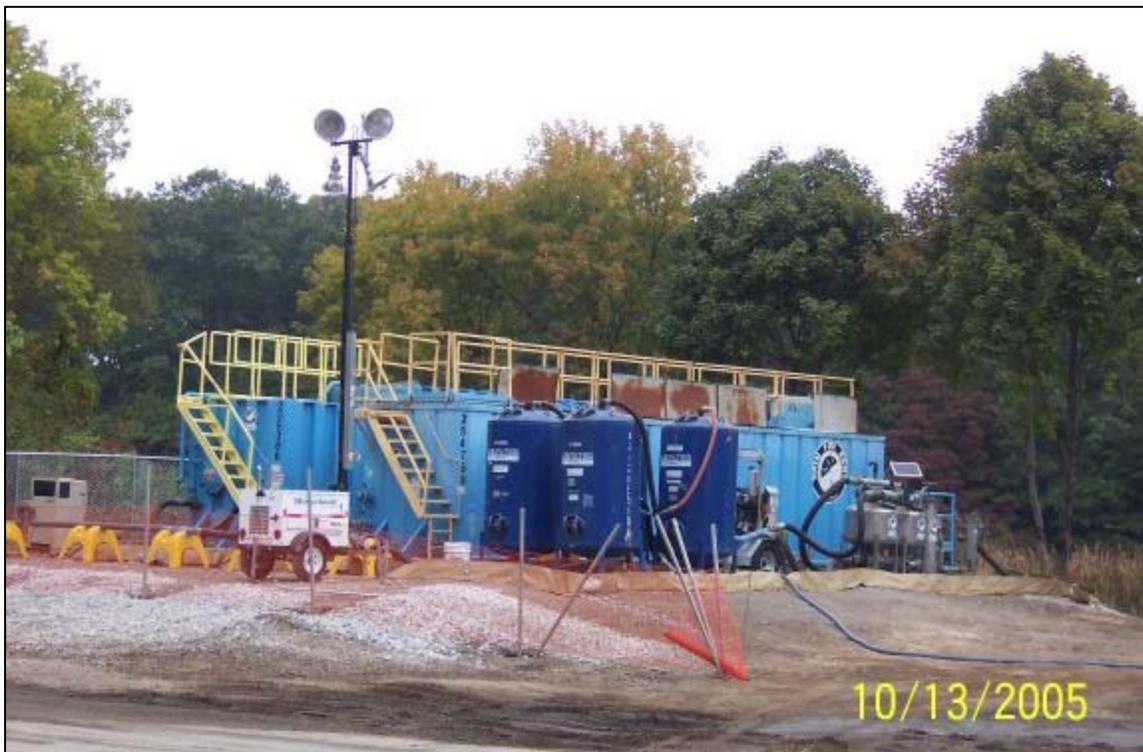
As discussed in Section 2.5, temporary dams and diversion channels were constructed to isolate excavation areas along Ruddiman Creek Main Branch. To further minimize water in these areas, groundwater and surface water that had accumulated from storm events were pumped to an on-site water treatment system, depicted in Figure 4-2. This system was also used to treat water generated during dewatering activities at the offloading pier and at each of the sediment staging areas. A total of 5,374,850 gallons of wastewater from the combined generation points was treated with the on-site system and discharged to the Muskegon County publicly owned treatment works.

**Figure 4-2 On-site treatment system**

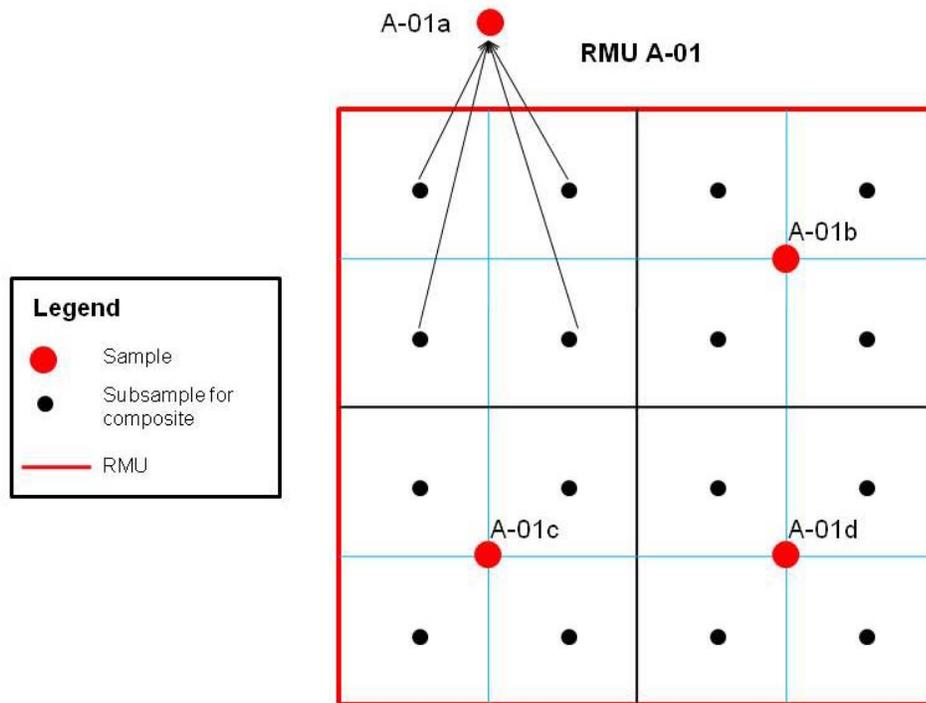
Based on the power curve and acceptable decision error, four sediment samples per RMU were determined to be necessary for evaluating the post-remediation site conditions against the project cleanup criteria. Therefore, each of the 100 x 100-foot RMUs was divided into four equal 50 x 50-foot cells, as illustrated in Figure 5-3, using RMU A01 as an example.

**Figure 5-3 Sampling grids in Ruddiman Pond RMU A01**

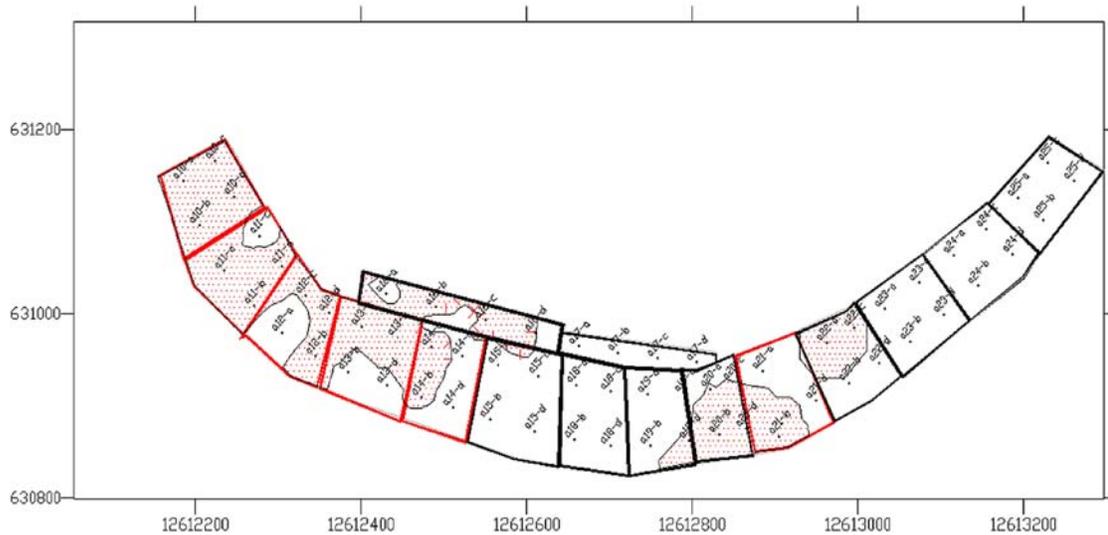
simplify secondary dredging efforts, the kriging model shown in Figure 6-1 was used to identify specific areas within RMUs A12-A14 to target for additional dredging. In this model, stippled areas were estimated to have a high probability of exceeding the target level for at least one COC, and were selected for removal of additional sediment.

**Figure 6-1 Kriging model used to determine sampling locations for RMUs A12 - A14**

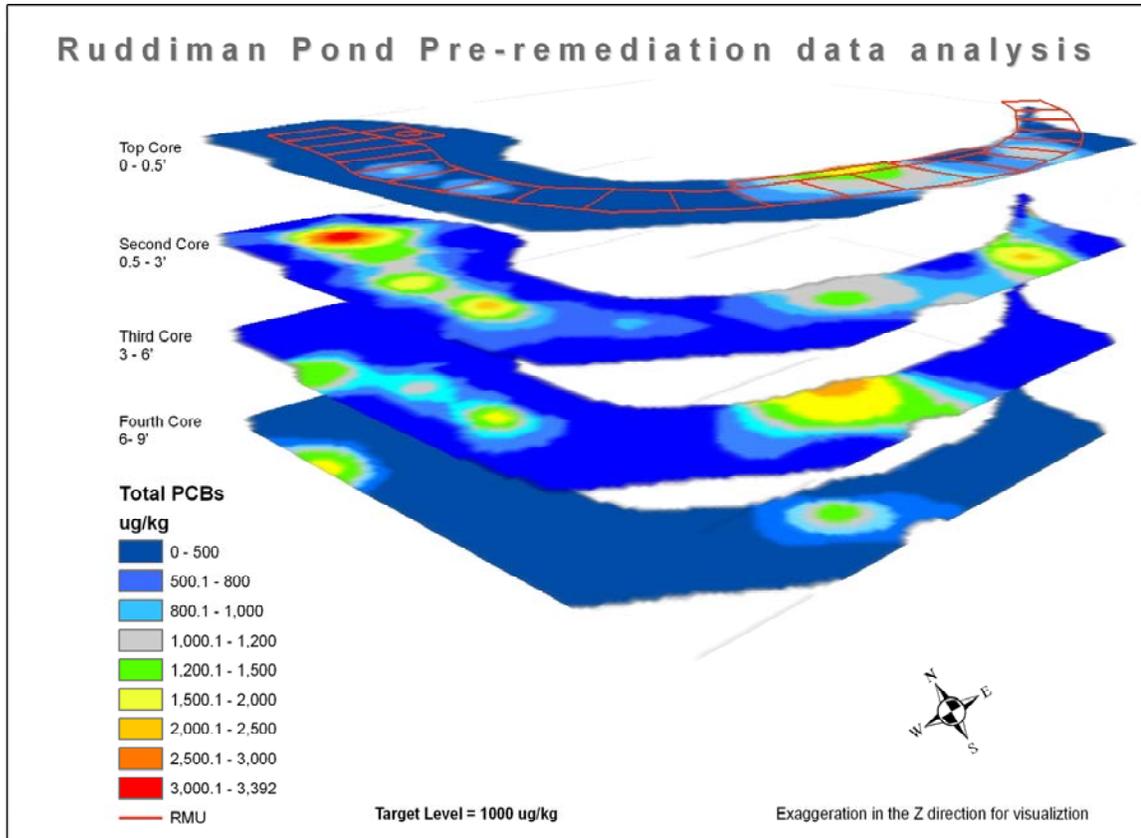
To further illustrate the effect of dredging on COC concentrations, Figures 6-2 through 6-4 show the estimated distributions of total PCBs throughout the pond remediation area. Figure 6-2 is a three-dimensional kriging map of the distribution of total PCB concentrations prior to any remedial activities. Figure 6-3 shows the distribution of total PCB concentrations after primary dredging. As the figures illustrate, the areas exceeding the total PCBs target level of 1,000  $\mu\text{g}/\text{kg}$  are found mainly in RMUs A1-A6 and A10-A12, plus an additional hotspot within RMU A20. Figure 6-4 shows the distribution of total PCB concentrations after secondary dredging. This figure illustrates the estimated total PCB concentrations fell below the target level throughout the site, with the exception of a hot spot around RMU A06 and a smaller area within RMU A12. Additional remedial activities including a sand residual cover were applied to this area, as

**Figure 6-2 Total PCB concentrations in Ruddiman Pond prior to remediation**

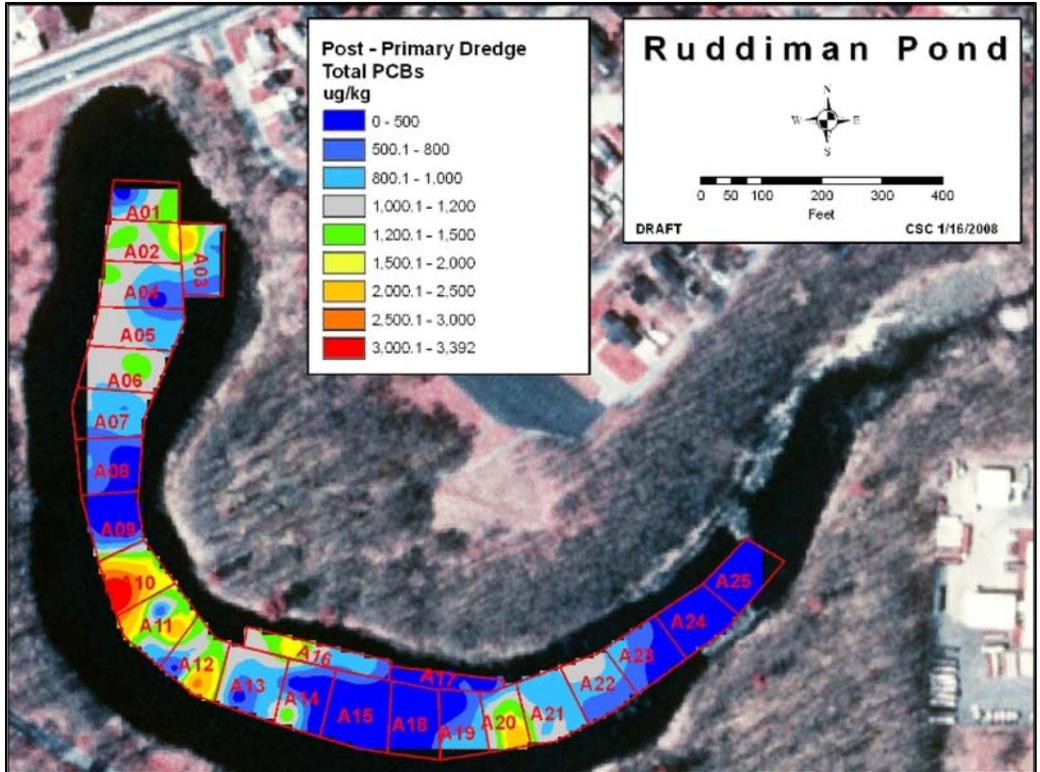
Figure 6-3 Total PCB concentrations in Ruddiman Pond after primary dredging

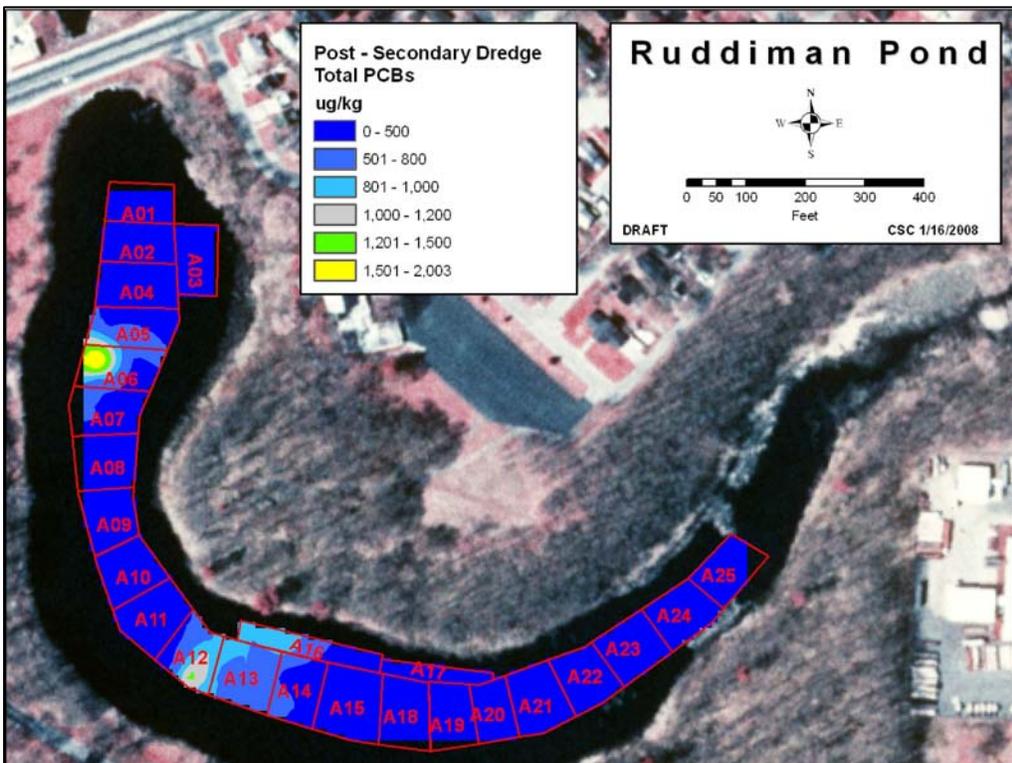
described in Section 6.4. The exceedance at RMU A12 only covered a small area and only slightly exceeded the target level, and as stated above, mean concentrations for total PCBs did not exceed the target level in RMUs A12-A14.

Figure 6-4 Total PCB concentrations in Ruddiman Pond after secondary dredging

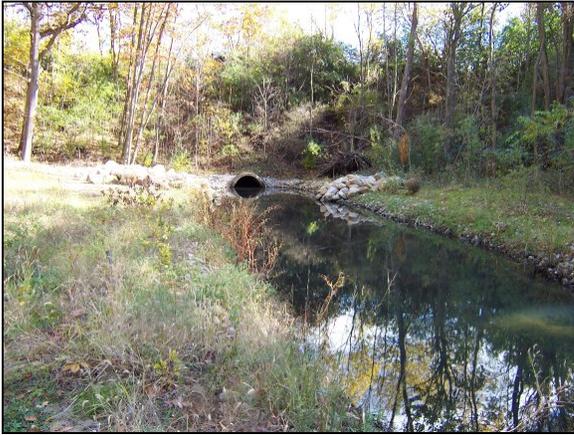
Historically, Ruddiman Creek Main Branch and Pond were severely affected by contamination from the area's industries and run-off from storm sewers. Aquatic life had all but disappeared and safe recreational opportunities were extremely limited. Following the removal of contaminated sediments from the creek and pond, salmon were seen swimming up the creek for the first time in many years and the visual appearance of the creek and pond were improved (Figures 9-1 and 9-2).

**Figure 9-1** Appearance of Ruddiman Creek Main Branch remediation area six months after completion of remediation project

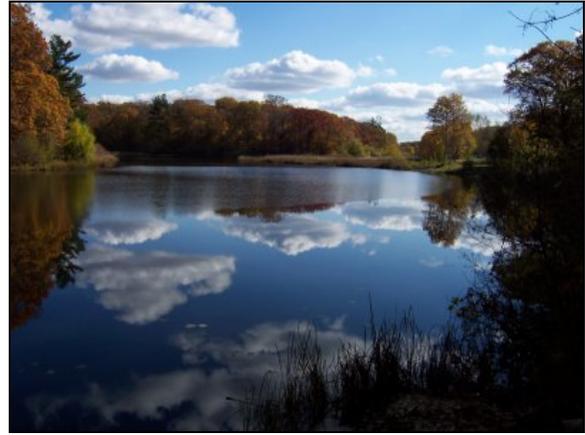
**Figure 9-2** Appearance of Ruddiman Pond remediation area six months after completion of remediation project
